RECOVERY PROGRAMME AFTER SEVERE SOIL EROSION: LESSONS LEARNED FROM THE VALE MOURO CASE

WHAT HAPPENED IN VALE MOURO?

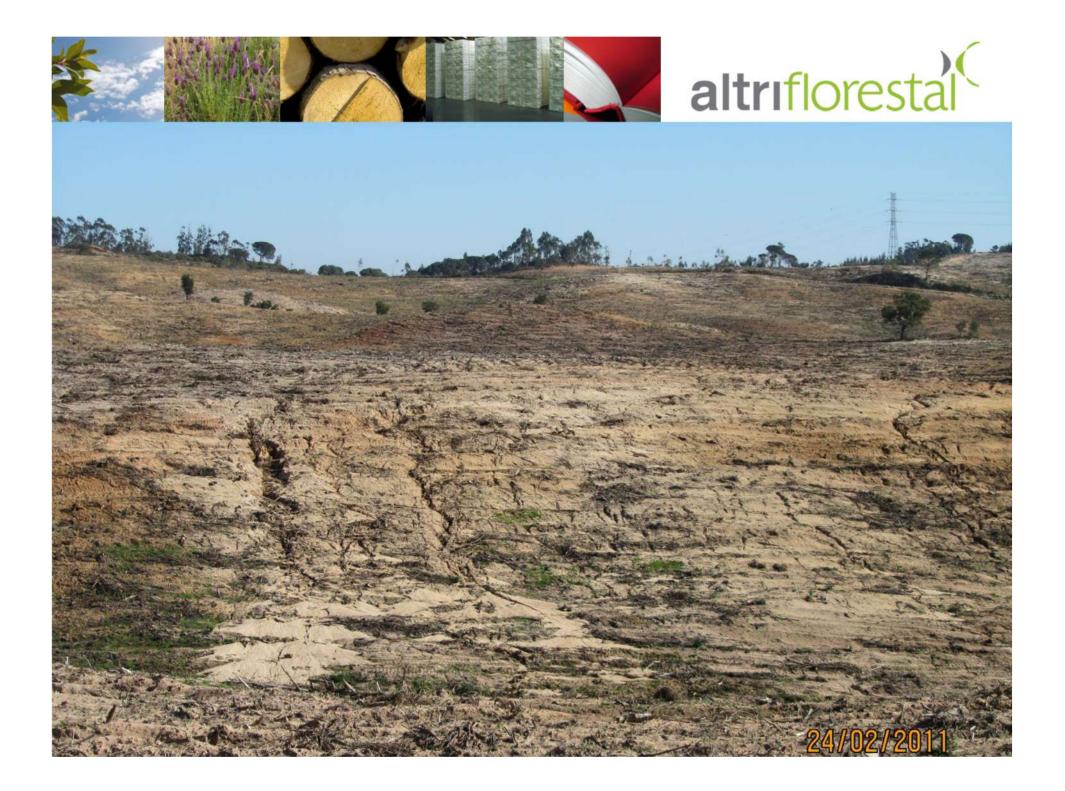
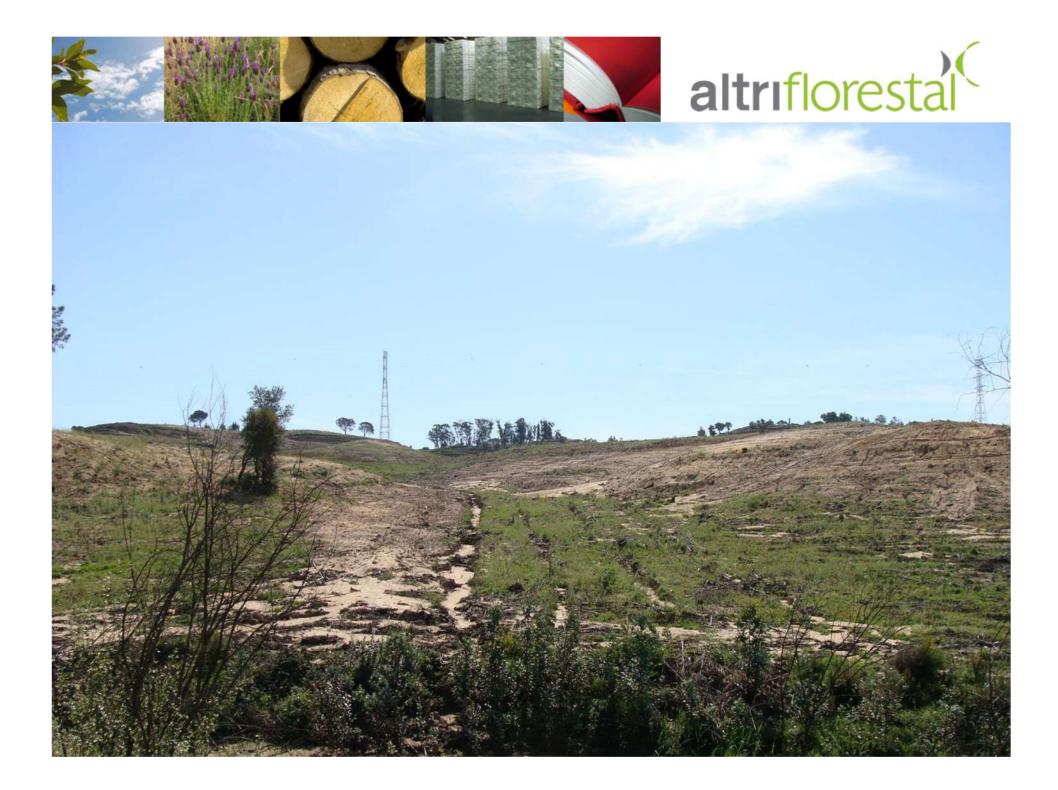
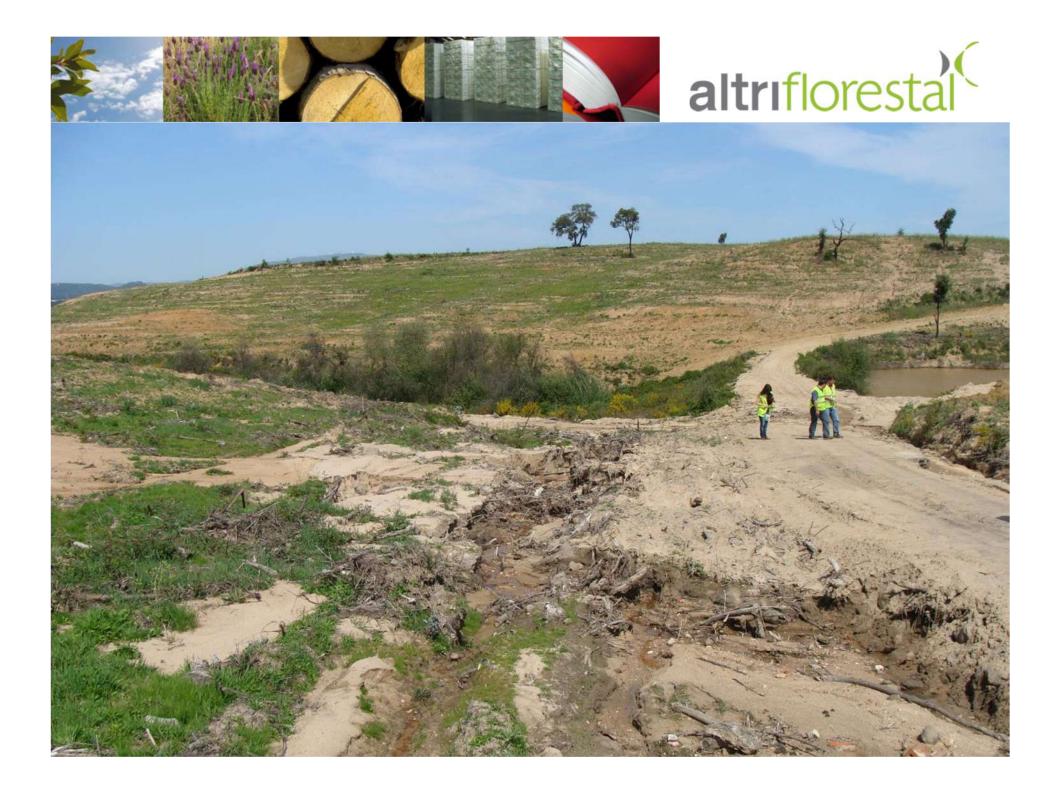
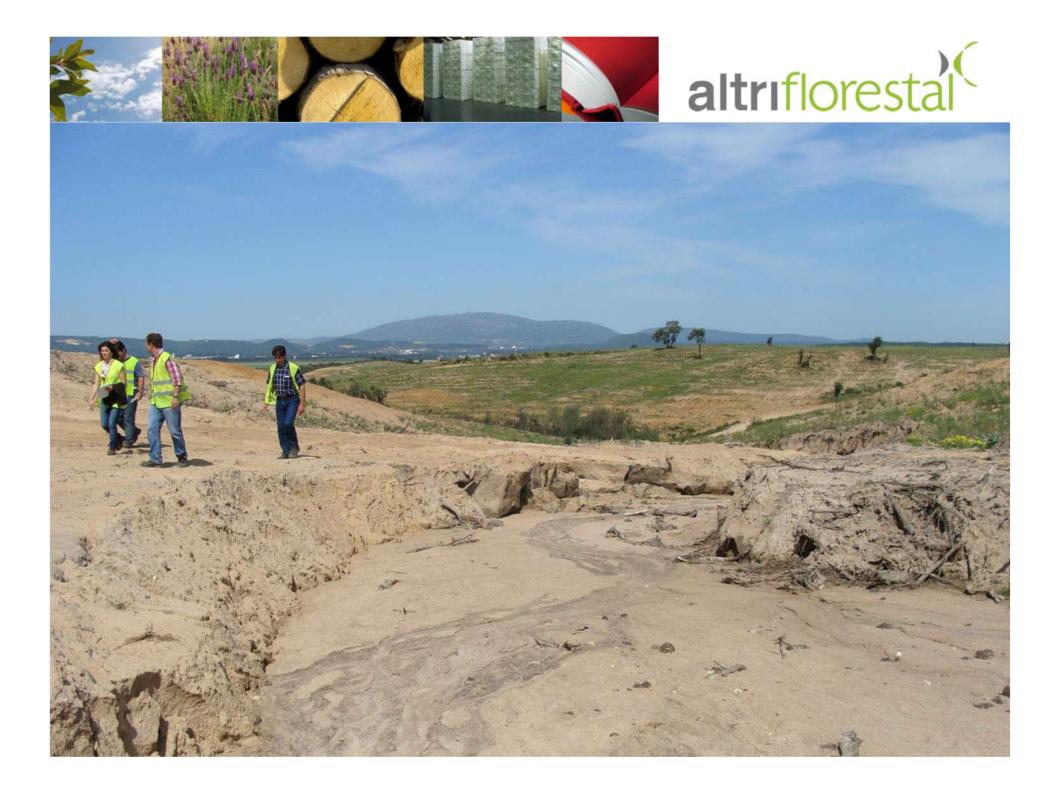
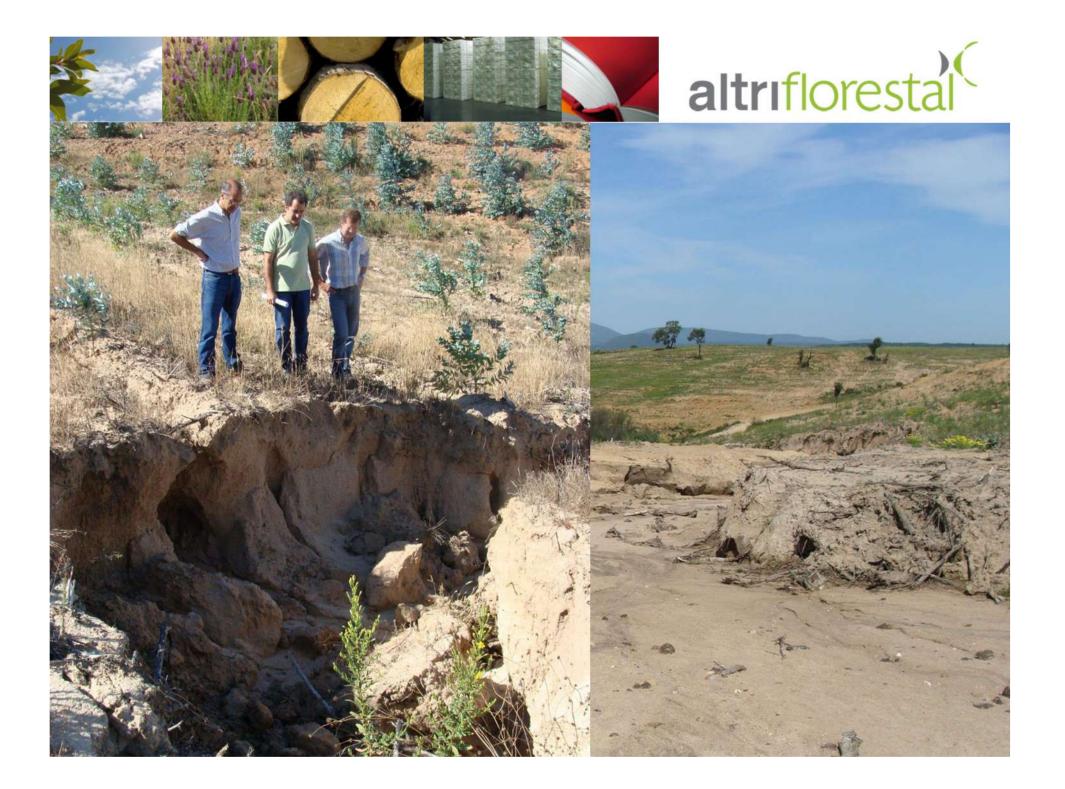
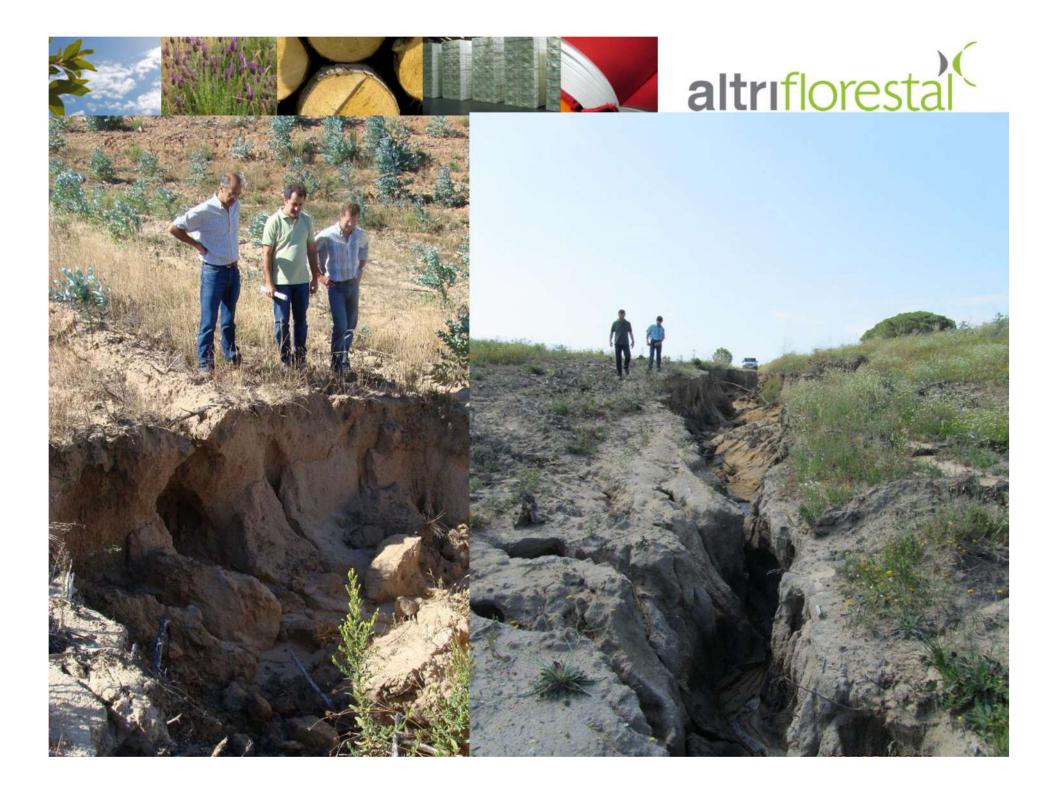
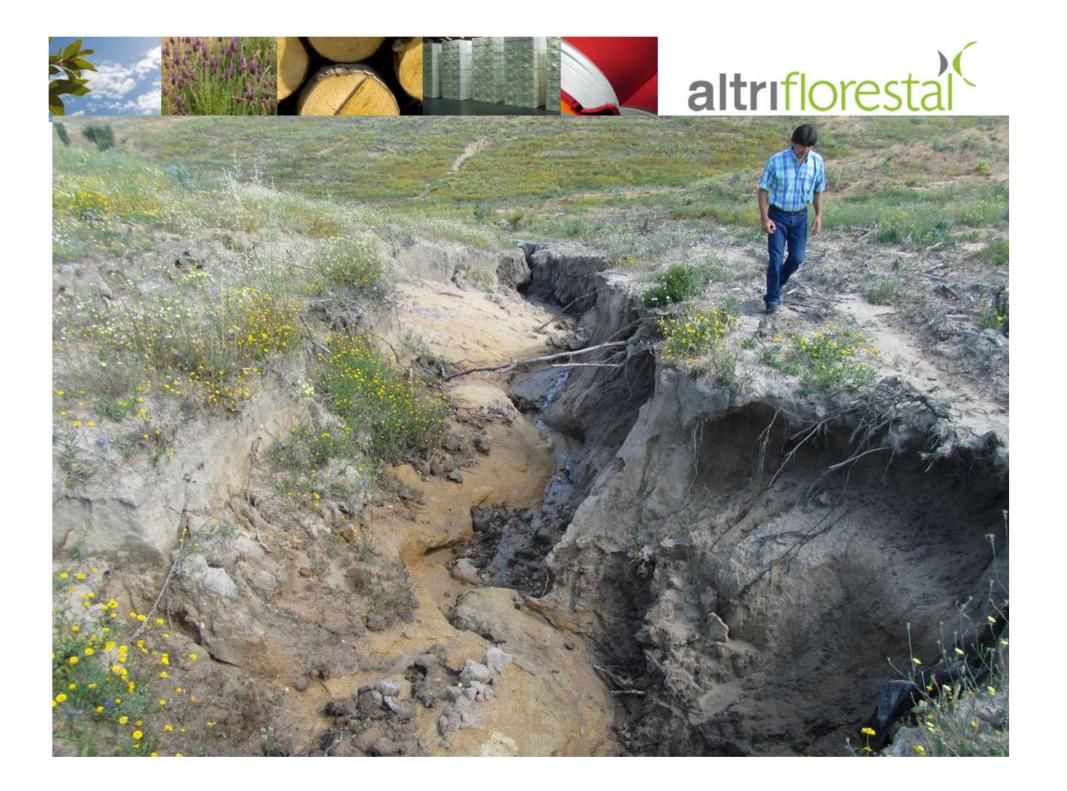
- Winter 2010/11: Very rainy winter and spring, with several moments of peak precipitation, originated severe erosion on the slopes and heavy sedimentation in the lower areas
- Soil recovery interventions started in March 2011 and continued untill the end of 2012
- The Vale Mouro case was the sole reason for the suspension of the company's FSC Forest Management certificate, with huge negative impact on a commercial level, public image of the company and public relations with ENGO and other stakeholders.
- So what were the erosion phenomena observed?

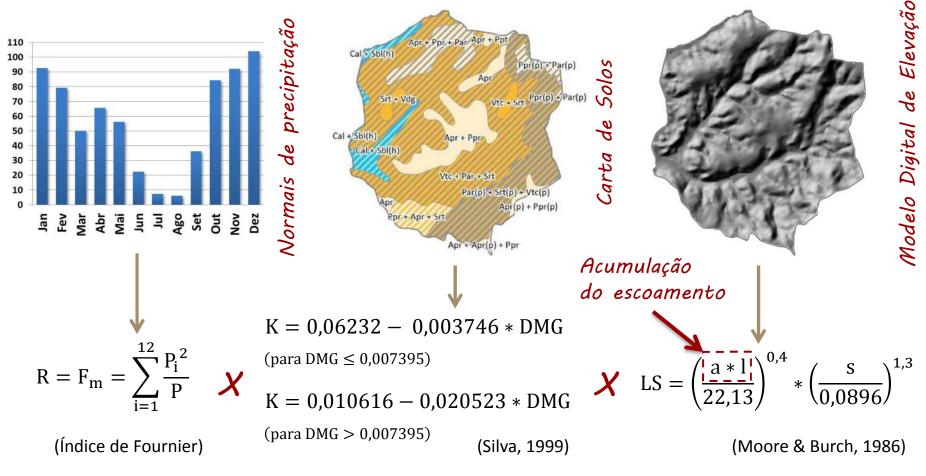
METODOLOGIA: modelação por adaptação da USLE

Avaliação da erosão hídrica potencial dos solos à escala da unidade de intervenção florestal com a utilização de um SIG

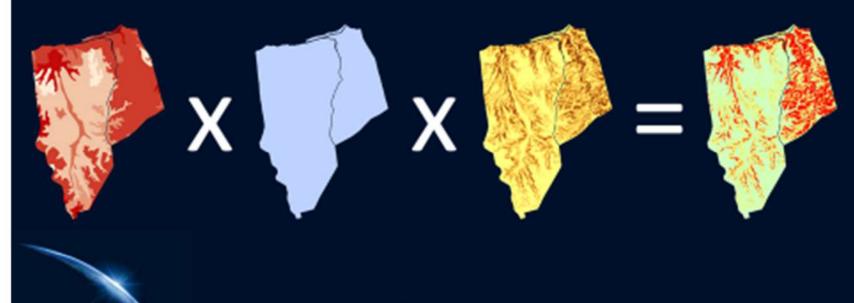
Carta de Risco de Erosão Potencial dos Solos

$K \cdot R \cdot LS = A$
